## CAA 112(r) INSPECTION REPORT

Name:	John W. Pray Water Treatment Plant	Date:	August 27-28, 2013
Address:	600 Phinney Park Drive, Fort Dodge, IA 50501		
County:	Webster	Phone No:	515.576.6101
Case No:	13IA0827	High Risk:	No
RMP No:	1000 0013 3134	FRS No:	1100 1308 6178
CAA Title V:	No	Program Level:	Program 3
Process:	Public water treatment plant for Fort Dodge, IA and some surrounding areas using chlorine gas as a disinfectant prior to distributing drinking water to residences and businesses.

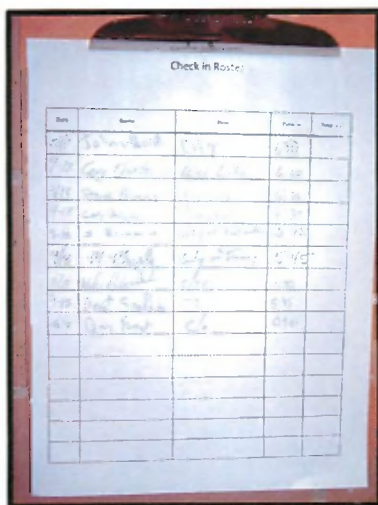
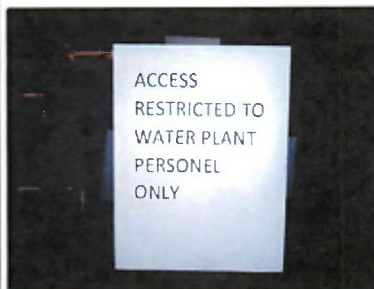
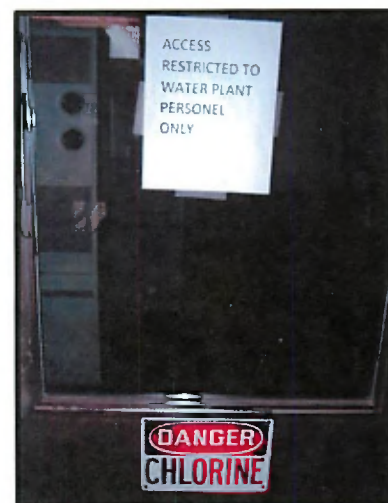
Post inspection, I received three photographs attached to the same email that contained the one-page document mentioned in an earlier paragraph. The three photographs appear to be related to a safe work practice to control the hazards possible from support personnel entrance into the stationary source. There were no written documents accompanying these photographs that developed the safe work practice regarding controlling support personnel entrance into the stationary source. The photographs are shown below.

None of the photographs or documents attached to the email addressed opening process equipment or piping.
